Phase 2 Focused Remedial Investigation Technical Memorandum

for the
**Diamond Head Oil Superfund
Site
Kearny, New Jersey**

July 2008

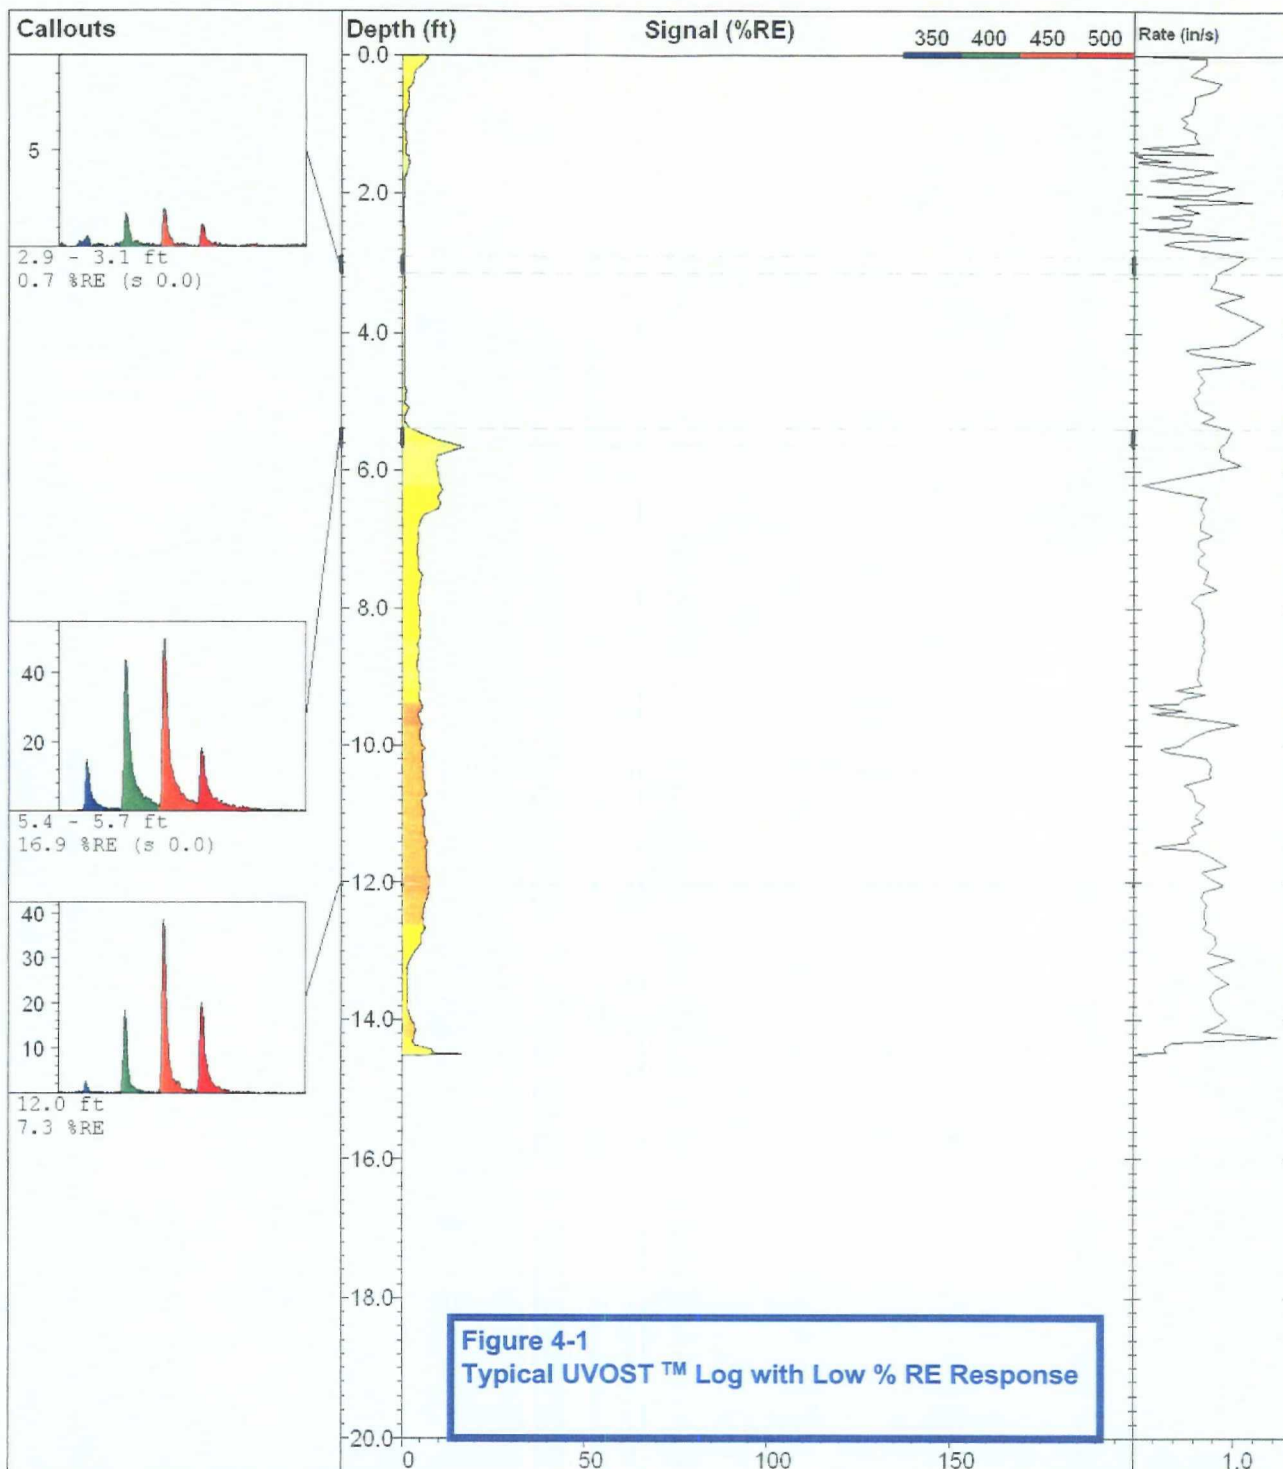
LIF-008

Max signal:
16.9 % @ 5.66 ft

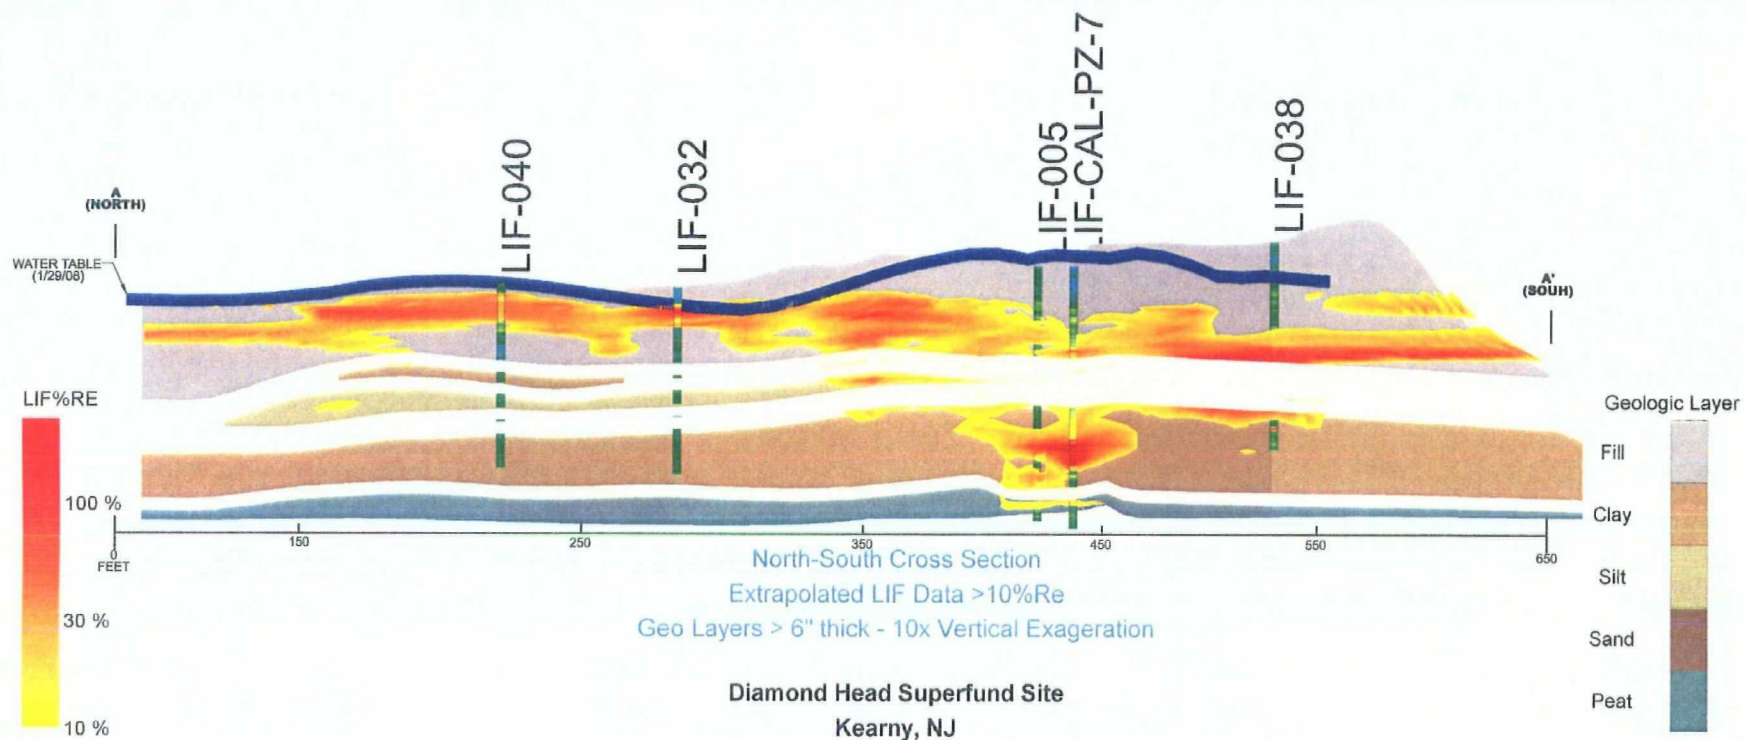
Figure 4-5
Cross Section A - A' of LNAPL
Distribution Based on LIF Data
Diamond Head - Focused Phase 2 RI
Kearny, New Jersey

1. THIS FIGURE SHOWS THE APPROXIMATE DISTRIBUTION OF LNAPL IN THE SUBSURFACE BASED ON MATHEMATICAL MODELS OF THE LIF DATA. COLOR CODING REPRESENTS THE TIME RESPONSE OF THE LIF DATA.
2. GEOLOGIC CONTACTS ARE ESTIMATED OR INFERRRED.
3. SCALE IS APPROXIMATE.
4. GEOLOGIC LAYERS ARE SHOWN IN "EXPLODED VIEW" TO ACCENTUATE LNAPL DATA.

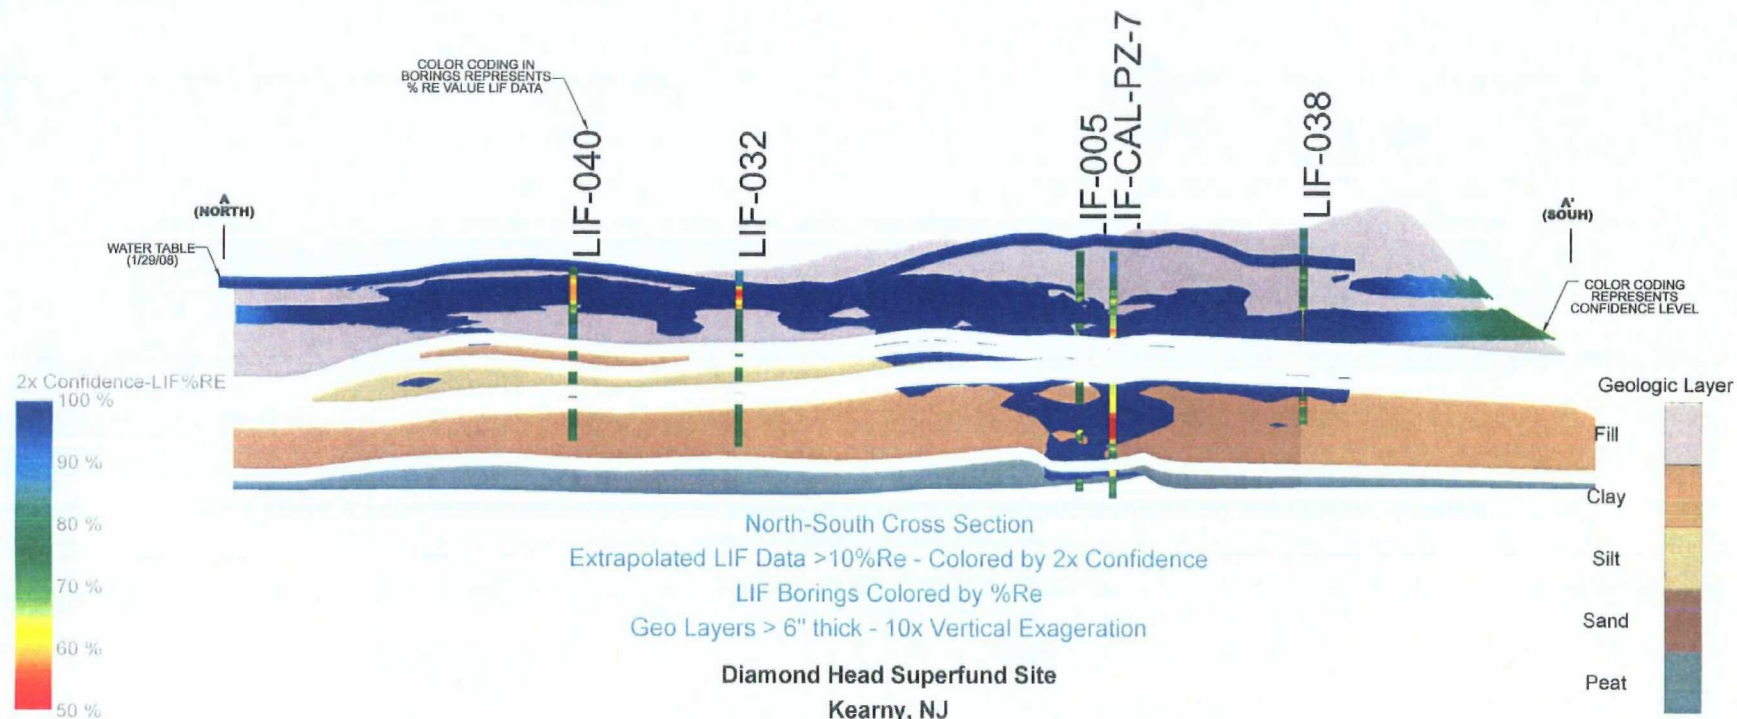
Figure 4-5A
Data Confidence Evaluation
for Cross Section A - A'
Diamond Head - Focused Phase 2 RI
Kearny, New Jersey

1. THIS FIGURE SHOWS THE CONFIDENCE LEVEL IN THE EXTRAPOLATED DATA. USED FOR THE CORRESPONDING CROSS-SECTION. COLOR CODING IN THE LIF BORING LOCATIONS REPRESENTS ACTUAL NIS DATA. COLOR CODING IN THE LIF MASS REPRESENTS THE CONFIDENCE LEVEL THAT THE PROBABILITY OF THE EXTRAPOLATED DATA IS WITHIN ± TWO TIMES THE INDICATED NIS VALUE. DARKER BLUE INDICATES HIGHER CONFIDENCE IN THE DATA.
2. GEOLOGIC CONTACTS ARE ESTIMATED OR INFERRED.
3. SCALE IS APPROXIMATE.
4. GEOLOGIC LAYERS ARE SHOWN IN "EXPLODED VIEW" TO ACCENTUATE LIF DATA.

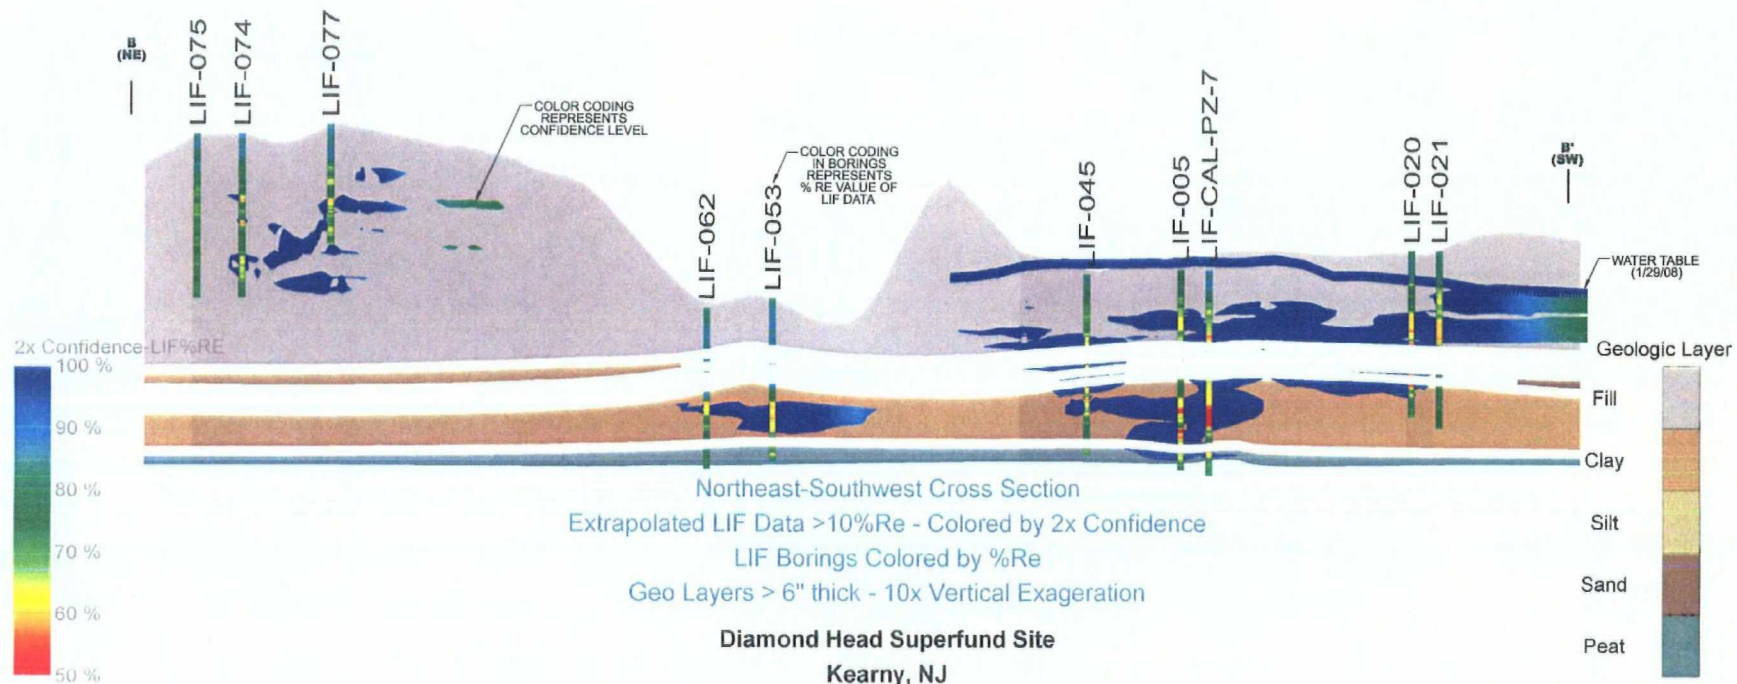
Figure 4-6A
Data Confidence Evaluation
for Cross Section B - B'
Diamond Head - Focused Phase 2 RI
Kearny, New Jersey

1. THIS FIGURE SHOWS THE CONFIDENCE LEVEL IN THE KNOWN DATA USED FOR THE CORRESPONDING CROSS-SECTION. COLOR CODING IN THE LIF BORING LOCATION REPRESENTS ACTUAL %RE DATA. COLOR CODING IN THE LIMP-045 REPRESENTS THE CONFIDENCE LEVEL THAT THE PROBABILITY OF THE EXTRAPOLATED DATA IS WITHIN +/- TWO TIMES THE INDICATED %RE VALUE. DARKER BLUE INDICATES HIGHER CONFIDENCE IN THE DATA.
2. GEOLOGIC CONTACTS ARE ESTIMATED OR INFERRRED.
3. SCALE IS APPROXIMATE.
4. GEOLOGIC LAYERS ARE SHOWN IN "EXPLODED VIEW" TO ACCENTUATE LIMP-045 DATA.

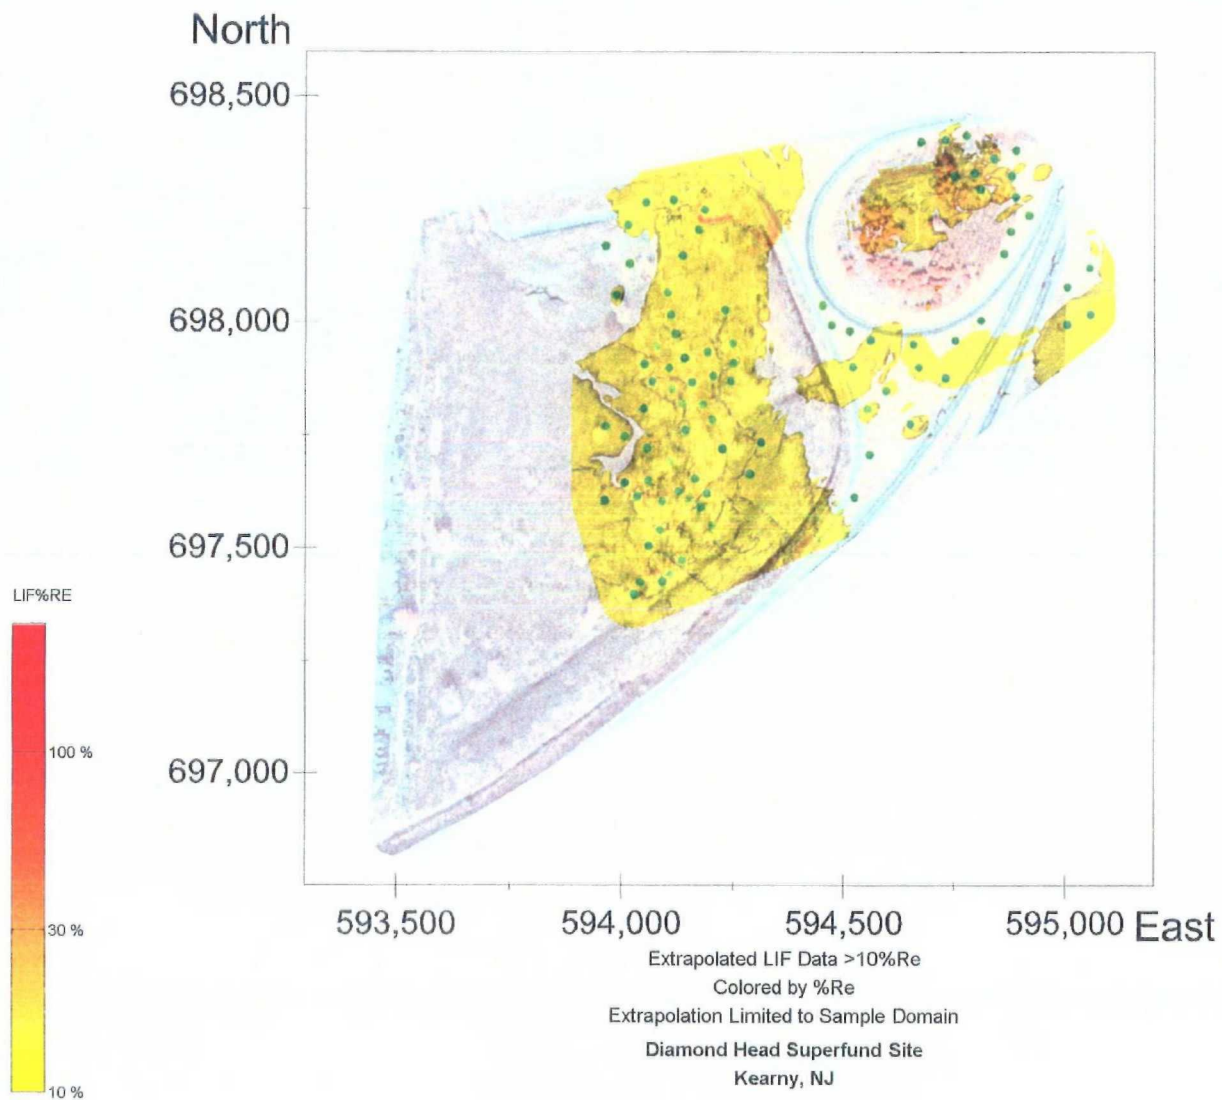
Figure 4-7
Lateral Extent of LNAPL,
LIF > 10% RE
Diamond Head - Focused Phase 2 RI
Kearny, New Jersey

THIS FIGURE SHOWS THE APPROXIMATE DISTRIBUTION OF LNAPL IN THE SUBSURFACE BASED ON MATHEMATICAL KRIGING OF THE LIF DATA. COLOR CODING REPRESENTS THE %RE RESPONSE OF THE LIF DATA.

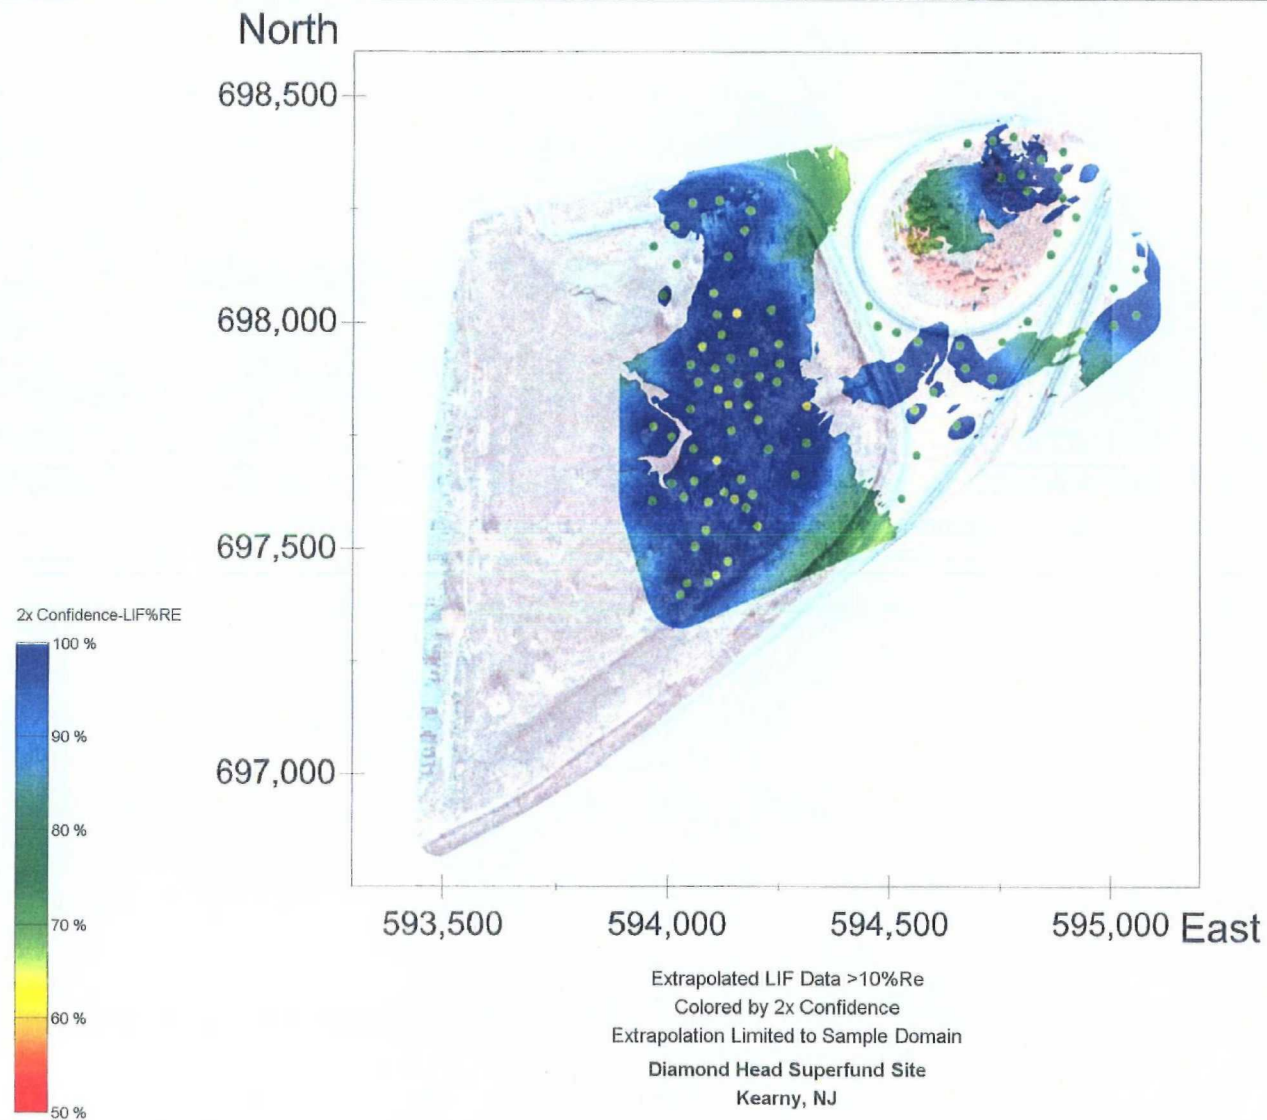
Figure 4-7A
Data Confidence Evaluation
for Lateral Extent of
LNAPL LIF >10% RE
Diamond Head - Focused Phase 2 RI
Kearny, New Jersey

THIS FIGURE SHOWS THE CONFIDENCE LEVEL IN THE KRIGED DATA USED FOR THE CORRESPONDING FIGURE. COLOR CODING IN THE LIF BORING LOCATION REPRESENTS ACTUAL %RE DATA. COLOR CODING IN THE LNAPL PLUME REPRESENTS THE CONFIDENCE LEVEL THAT THE PROBABILITY OF THE EXTRAPOLATED DATA IS WITHIN +/- TWO TIMES THE INDICATED %RE VALUE. DARKER BLUE INDICATES HIGHER CONFIDENCE IN THE DATA.

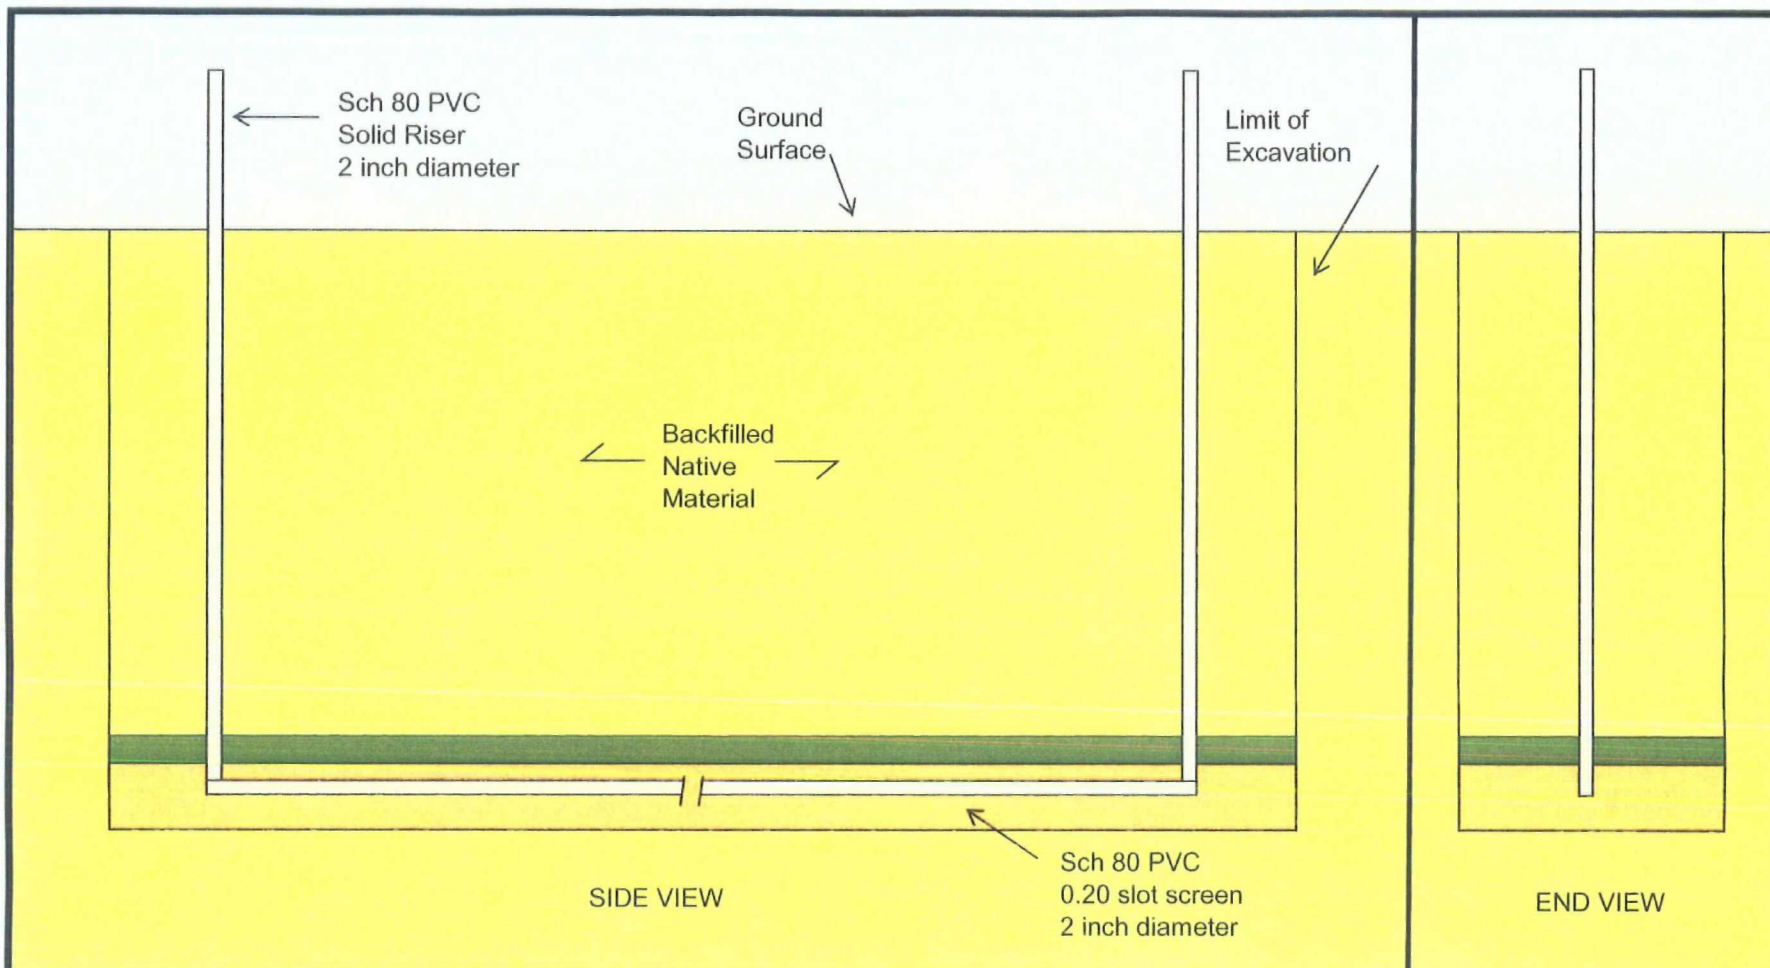
- Bentonite
- Sand
- Native Soils

System Dimensions
 Slotted lateral - 30' long x 7' deep
 Pipe - 2 inch diameter, 0.20 slot
 Sand - 18" thick
 Bentonite - 6" thick

- Pilot scale air/bio sparge test to support the evaluation of bio-sparging for the bioremediation of residual LNAPL. For the test, a horizontal sparge well approximately 30 feet long to a depth of about 10 feet bgs was constructed and five temporary 1-inch-diameter well points installed using direct push technology to monitor groundwater conditions in the area of the test. The sparge test was then conducted by first starting out at low injection rates, demonstrating steady-state conditions are achieved, and then stepping up to a higher injection rate. Field parameters in groundwater were monitored during the test and groundwater samples were collected from the temporary well points before and at the end of the test for analysis for VOCs and bacterial counts. The air/bio sparge field test continued for 10 days.
